HAIRY MAN ROAD / BRUSHY CREEK ROAD SAFETY IMPROVEMENTS

PROJECT BACKGROUND

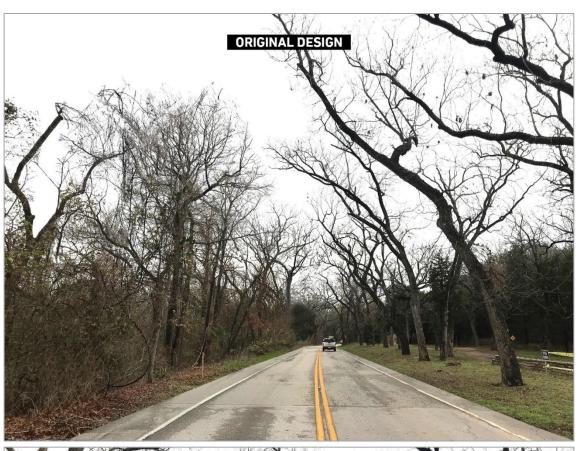
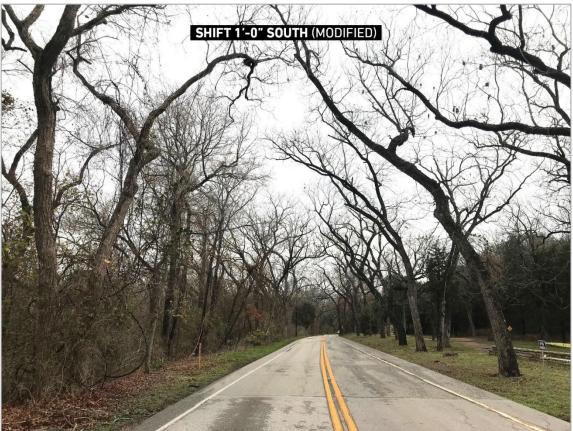
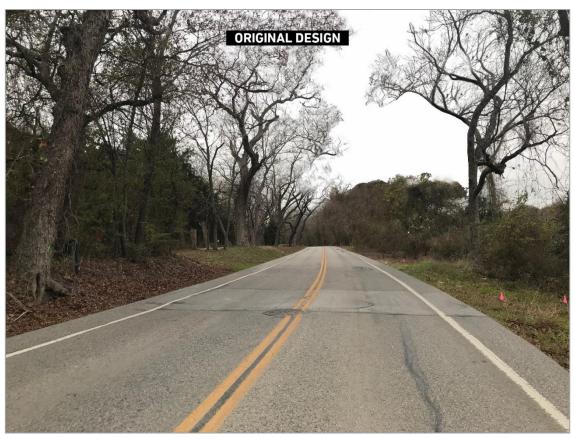
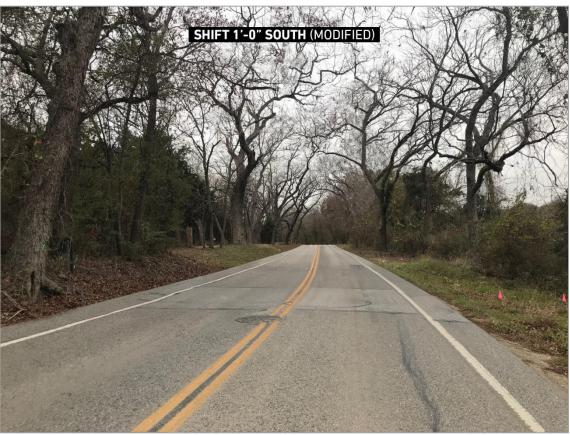
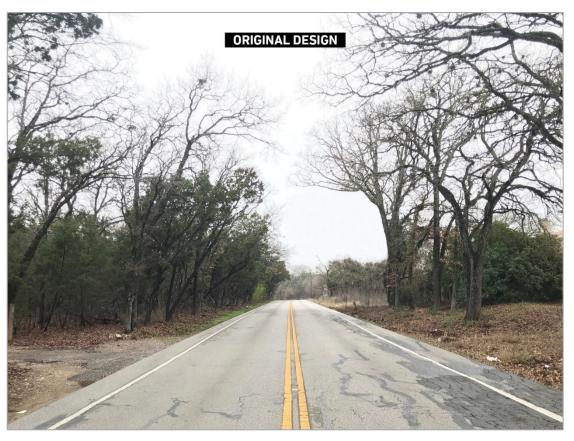
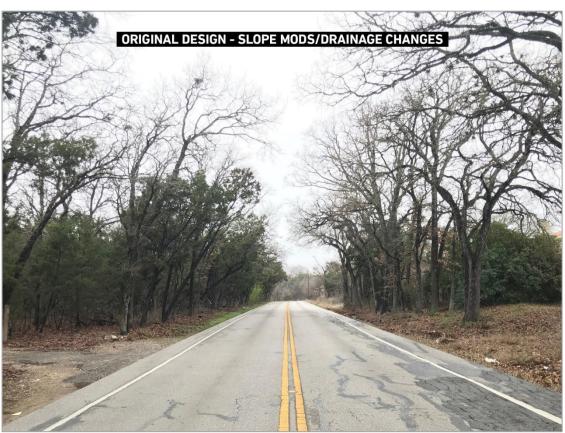
Below this summary are before and after photos that show the difference between the trees impacted by the original design and the impacts by the updated design.

The steering committee chose the option that shifted the pavement one foot south and modified drainage elements in order to minimize impacts to trees significant to the corridor's canopy area.

This option was able to reduce the number of impacted trees by 25%, bringing the number down from over 100 trees to 77 impacted trees. The collaboration and discussions between the project team and the community, including the feedback received during the open houses, resulted in an overall reduction of impacted trees by 69%.

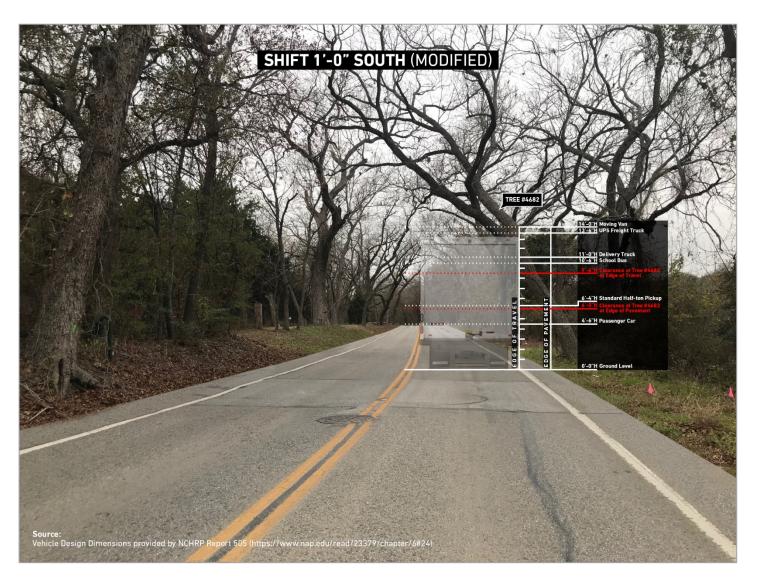
VERTICAL CLEARANCE

The graphic below shows how Tree #4682 will be a hazard once the safety improvements are constructed and the pavement is shifted to the south.
